Pentium® Pro Processor Specification Update

Release Date: February 1998

Order Number: 242689-025

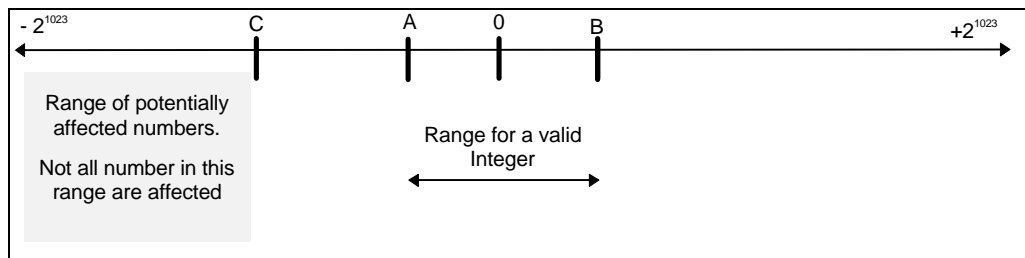
IMPLICATION: Erroneous operation results when the operand is so large that it will not fit into the target data size. The operands affected by this erratum are significantly outside (by a factor of 3X) the range that can be, correctly, converted to an integer value. The figure below and corresponding table identifies the normal range of integer numbers (between A and B) and the starting point of the operands affected by this erratum. Discrete failing operands will be present in the range between point C and the maximum negative number that can be represented by the processor (-2^{1023} in double precision format). Note 2 below gives a qualitative description of the nature of the discrete failing values. Software that does not rely on the Invalid Operation exception flag being set and signaled by either an exception OR by software polling is not impacted by this erratum.

16-bit Operation	A	B	C
	-32,768.0	+32,767.0	< -98304.0
32-bit Operation	A	B	C
	-2,147,483,648.0	+2,147,483,647.0	< -6,442,450,944.0

WORKAROUND: Any of two software workarounds will avoid occurrence of this erratum:
